RE: Preliminary Review/Visual Site
Inspection Report
UCAR Carbon Company, Parma
OHD 003 926 748

Enclosed you will find a copy of the UCAR Carbon Company, Parma, Preliminary Review/Visual Site Inspection (PR/VSI) report prepared by A.T. Kearney, Inc., for the United States Environmental Protection Agency.

The photographs on the following pages document the observations made during the VSI. The photographs are identified by a number which corresponds to an appropriate SWMU identifier. In instances where several photographs are provided for one unit, a decimal and sequential number will be used to denote the photograph sequence (i.e., 1.1, 1.2, and 1.3 denote photographs associated with SWMU No. 1).

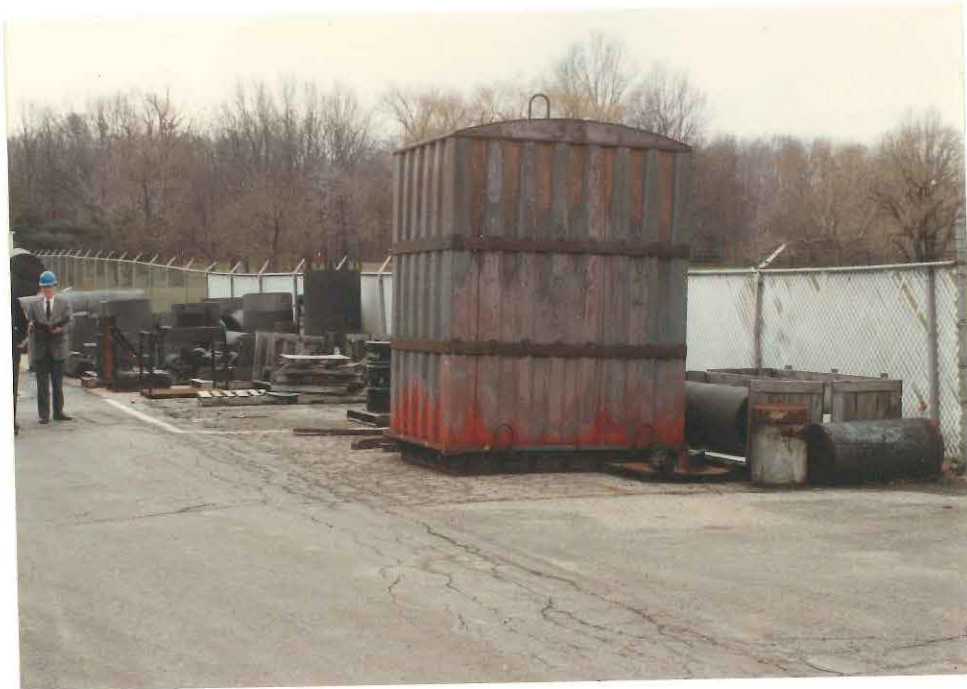
Unit Description: This outdoor unit is an asphalt-covered area approximately 32 feet long by 16 feet wide located west of Building No. 6. This unit is the RCRA-regulated "final" storage area for hazardous waste prior to off-site removal. It is designed to accommodate a maximum of fifty 55-gallon drums of hazardous waste (Reference 29). According to the September 1989 "Closure Plan for Container Storage Areas," the asphalt area and underlying soils to the west of this unit will be tested for contamination. Remedial measures will be initiated if contamination is detected as part of the closure plan for this unit (Reference 29). During the VSI, severely corroded asphalt was observed at this unit (Reference 21).

- 1.1 Hazardous Waste Container Storage Area No. 1. View looking south of the location of this outdoor unit. According to the facility representative, hazardous waste containers were formerly stored at the location of the salvagable equipment in the foreground.

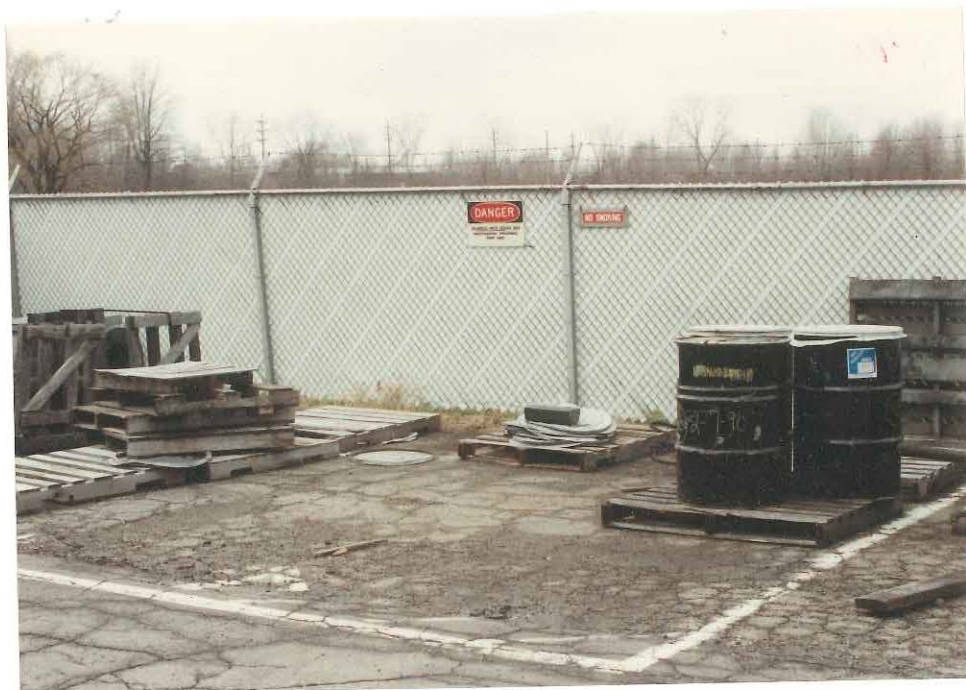
Release Controls: No release controls were identified for this unit which is located outdoors and constructed of a now-corroded asphalt base (Reference 31).

Conclusions: Soil/Ground Water: The release potential to the soil/ground water is moderate due to the deteriorated asphalt, outdoor location, and age of the unit.

- 1.2 Hazardous Waste Container Storage Area No. 1. View looking southwest of the outdoor unit. The area defined by the white markings is used for storage of hazardous waste. Note the corroded asphalt at this unit.

The RCRA-regulated Hazardous Waste Storage Area No. 1 (SWMU 1) was observed to have a moderate potential for releases to the subsurface based on documentation of past releases and poor integrity of the asphalt pad. Continued monitoring and implementation of the approved RCRA Closure Plan is suggested for this unit.

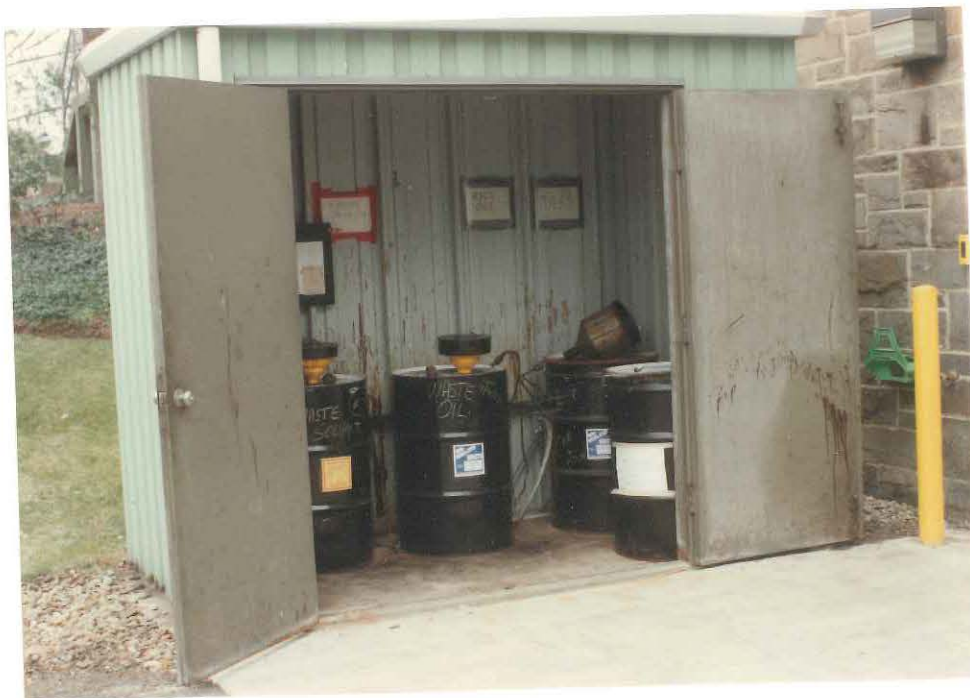
Unit Description: This outdoor unit is a steel storage shed approximately 10 feet long by 5 feet wide by 10 feet high located northwest of the shipping and receiving area at Building No. 1. This unit has steel lockable doors, a concrete base, and an approximately one-inch high curb at the entrance (Reference 31). The unit has a capacity of approximately 10 55-gallon drums. It is used for less-than-90-day storage of steel 55-gallon drums of waste solvents, waste oil, waste tar and pitch, waste polyacrylonitrile and dimethyl sulfoxide (Reference 31). During the VSI, dark staining was observed on the walls and base of this unit; however, no evidence of release to adjacent soils was identified (Reference 31).

2. Hazardous Waste Container Storage Area No. 2. View looking east of this steel shed. Note minor staining on walls and floor of unit.

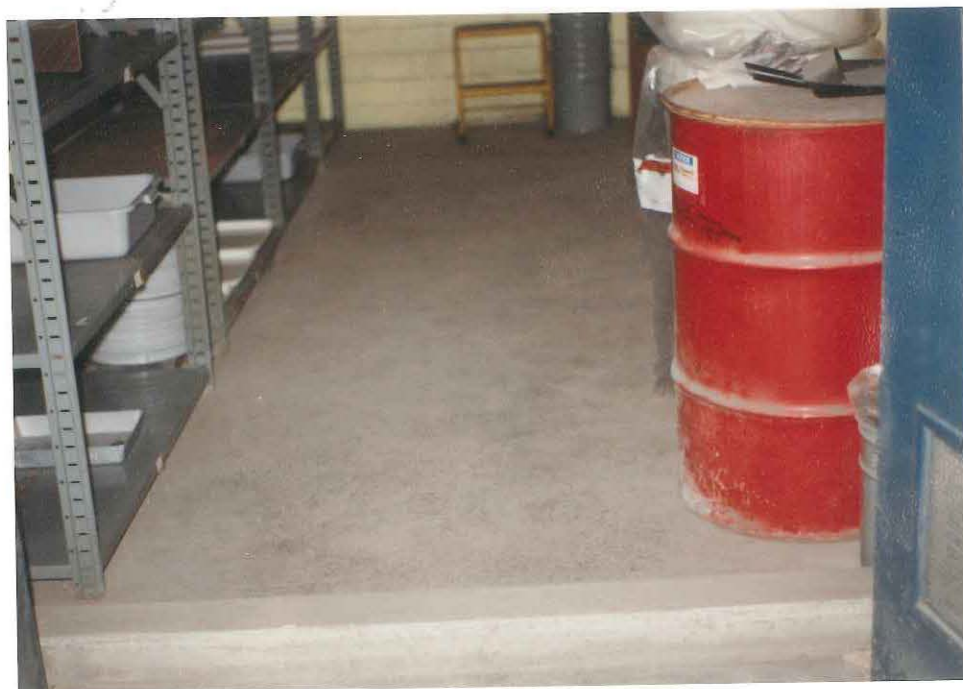
3. Hazardous Waste Container Storage Area No. 3. View looking east of this concrete-paved unit.

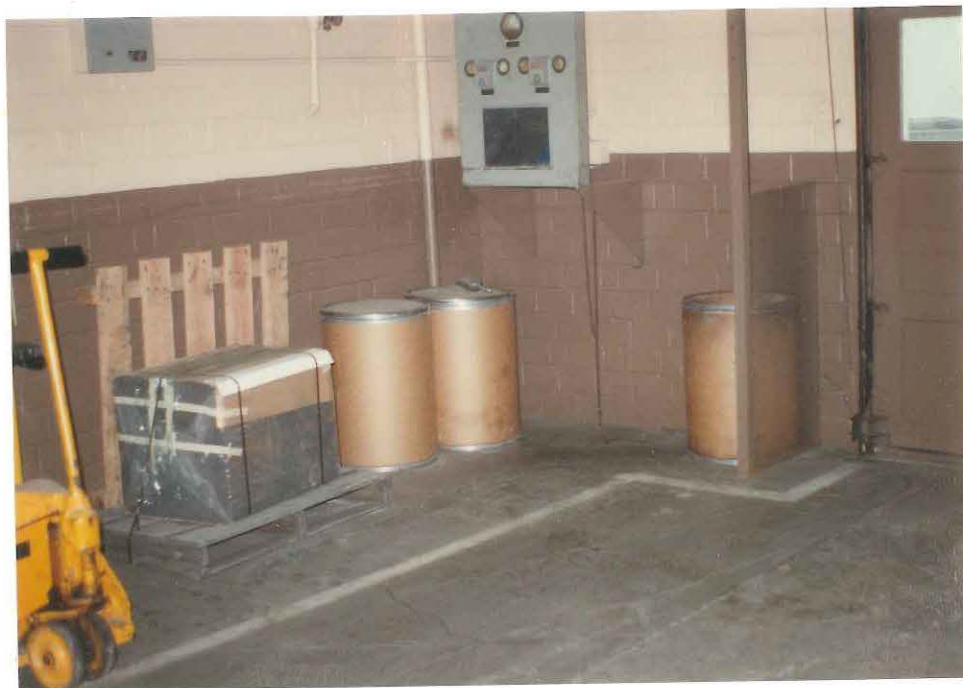
Unit Description: This indoor unit was a storage area approximately five feet long by three feet wide located in the northwest corner of the shipping and receiving room. According to facility representatives, two drums used for accumulation of waste solvents and waste oils were stored at this location. During the VSI, minor dark staining was observed in the vicinity of this unit; however, no evidence of a release outside the area was identified (Reference 31).

4. Former Hazardous Waste Drum Storage Area. View looking northwest of the location of this former drum storage area for waste solvents and oils. According to the facility representative, wastes are no longer stored at this location.

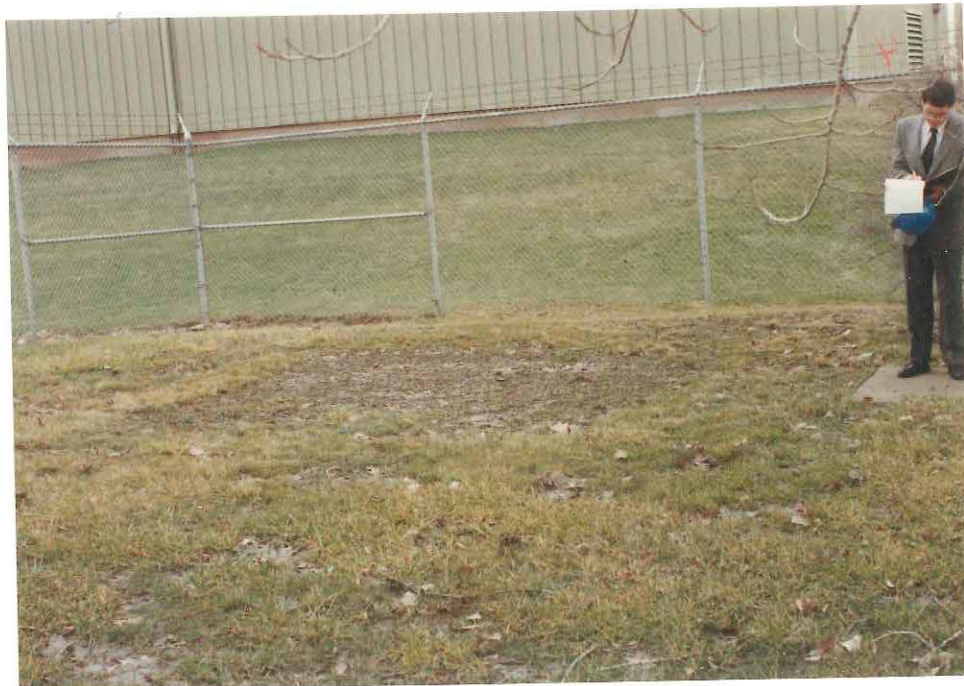
History of Releases: This unit was designed as an area where spent laboratory chemicals were placed on gravel and allowed to react. During the VSI, evidence of stressed vegetation (brown grass) was observed at the site of this unit (Reference 31).

Conclusions: Soil/Ground Water: The release potential to soil/ground water is high based on the practice of reacting laboratory chemicals at this unit, the unlined nature of the unit, and the stressed vegetation observed during the VSI.

5. Former Chemical Reacting Site. View looking southeast of this outdoor unit. Note the rectangular-shaped area of stressed vegetation at the center of the photograph.

The Former Chemical Reacting Site (SWMU 5) was determined to have a high potential for the release of hazardous wastes or constituents to the subsurface, based on the former waste management practices and the observation of stressed vegetation at the site during the VSI. The Scrap Metal Dumpster (SWMU 9) was also determined to have a high potential for release of hazardous wastes or constituents to the subsurface, as evidenced by a dark oily substance observed on the soils adjacent to the unit during the VSI. A RCRA Sampling Visit is suggested for both units.

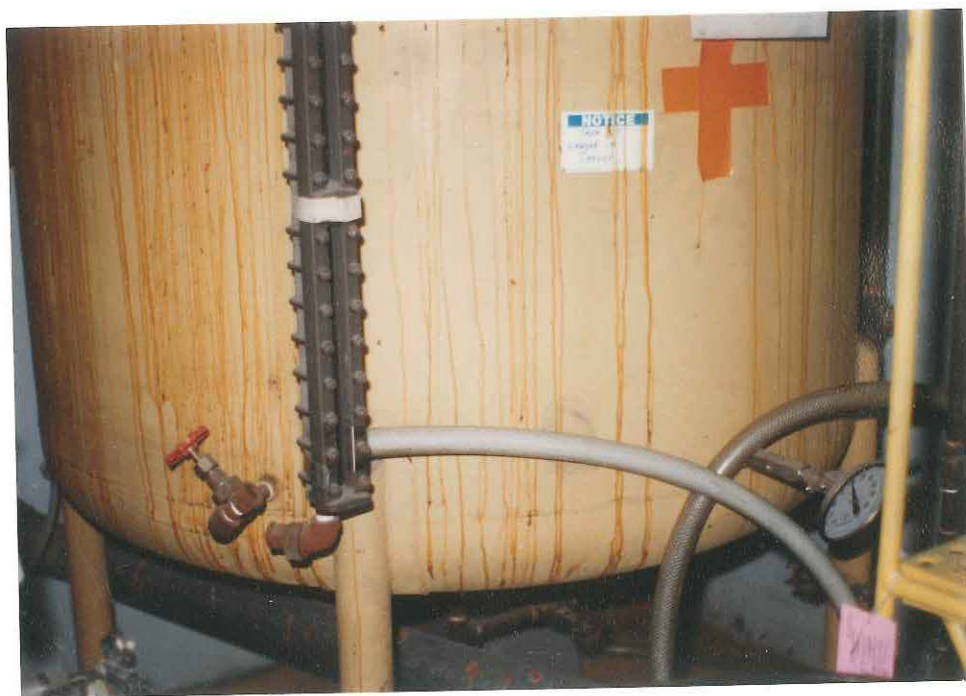
Unit Description: This indoor unit is an approximately 500-gallon above-ground steel tank located in Room 10E (Polyacrylonitrile Reactor Room) in the northeast corner of the Services Area of Building No. 1. It is used to collect wastewater containing dimethyl sulfoxide, polyacrylonitrile, and water generated in the Polyacrylonitrile Reactor Operations (Reference 31). According to facility representatives, the unit was taken out of service due to corrosion in early 1985 (Reference 33). During the VSI, evidence of leakage of wastewater was observed on the side of the tank and on the floor in the vicinity of the unit; however, no evidence of a release outside Room 10E was identified (Reference 31).

7. Former Waste Dimethyl Sulfoxide Tank. View looking west of this inactive steel tank. Note the evidence of drippage on the side of this diked above-ground tank.

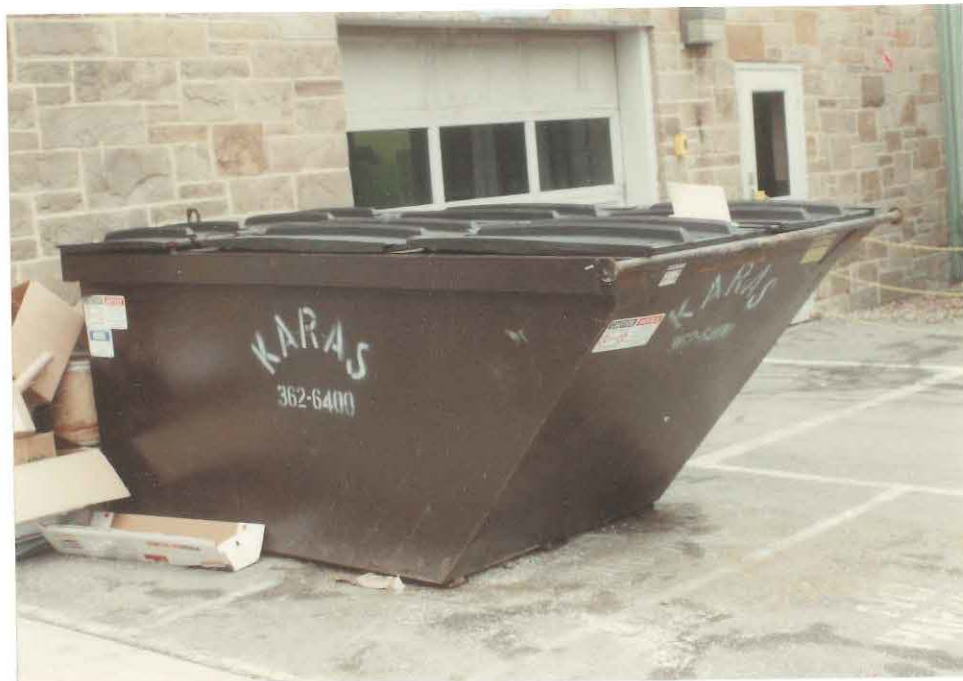
8. Municipal Waste Dumpster. View looking southwest of this steel unit used for storage of solid inert municipal wastes. According to the facility representative, this unit is emptied daily.

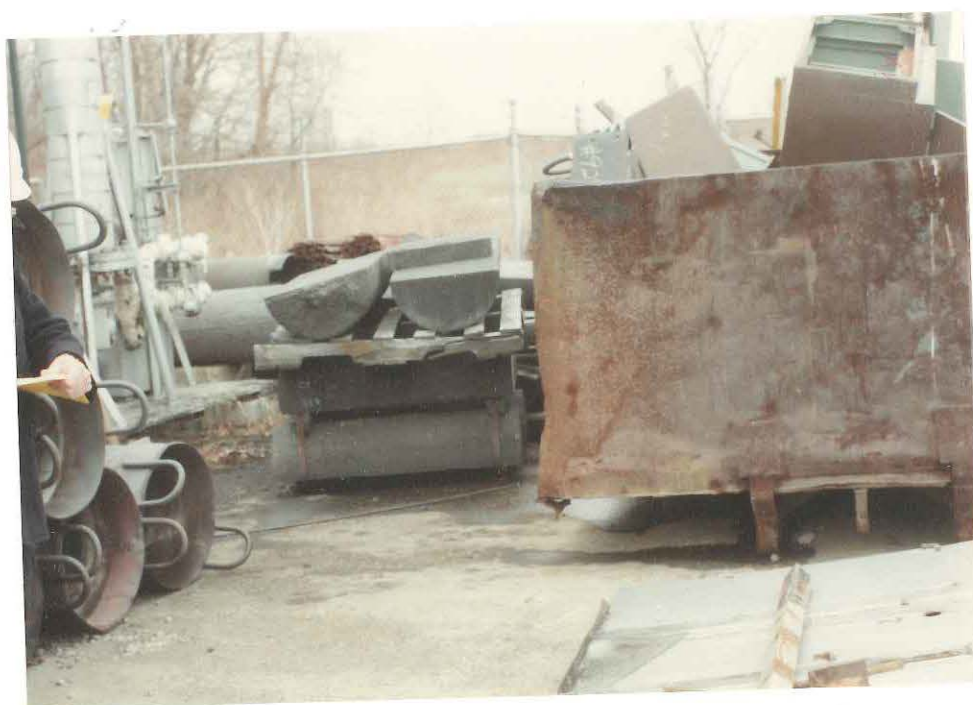
Unit Description: This outdoor unit is an approximately 20-cubic-yard steel dumpster located north of Building No. 3 (Auxiliary Lab). It is used for storage of scrap metal primarily generated in the Pilot Plant and laboratories, prior to removal for salvaging off-site. It is uncovered and located above a concrete pad. During the VSI, this unit was observed to be rusted, dented, and corroded. Evidence of leakage of a dark oily liquid was observed on the concrete beneath this unit and on adjacent soils, during the VSI (Reference 31).

History of Releases: During the VSI, evidence of leakage of a dark oily liquid was observed on the concrete beneath this unit and on adjacent soils (Reference 31).

Conclusions: Soil/Ground Water: The release potential to soil/ground water is high due to the observed leakage of a dark oily liquid on adjacent soils.

- 9.1 Scrap Metal Dumpster. View looking northeast of this 20-cubic-yard steel unit shown in the right portion of photograph. Note the leakage of a dark oily liquid beneath the dumpster.

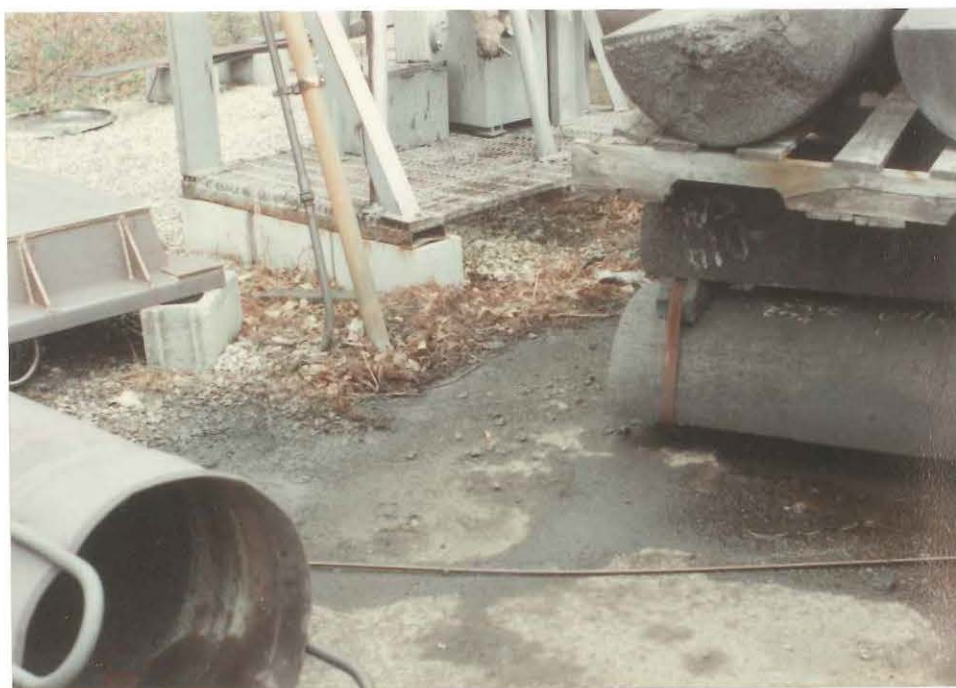
9.2 Scrap Metal Dumpster. Close-up view of dark oily stains originating from the Scrap Metal Dumpster and leading to adjacent soils shown in background of photograph.

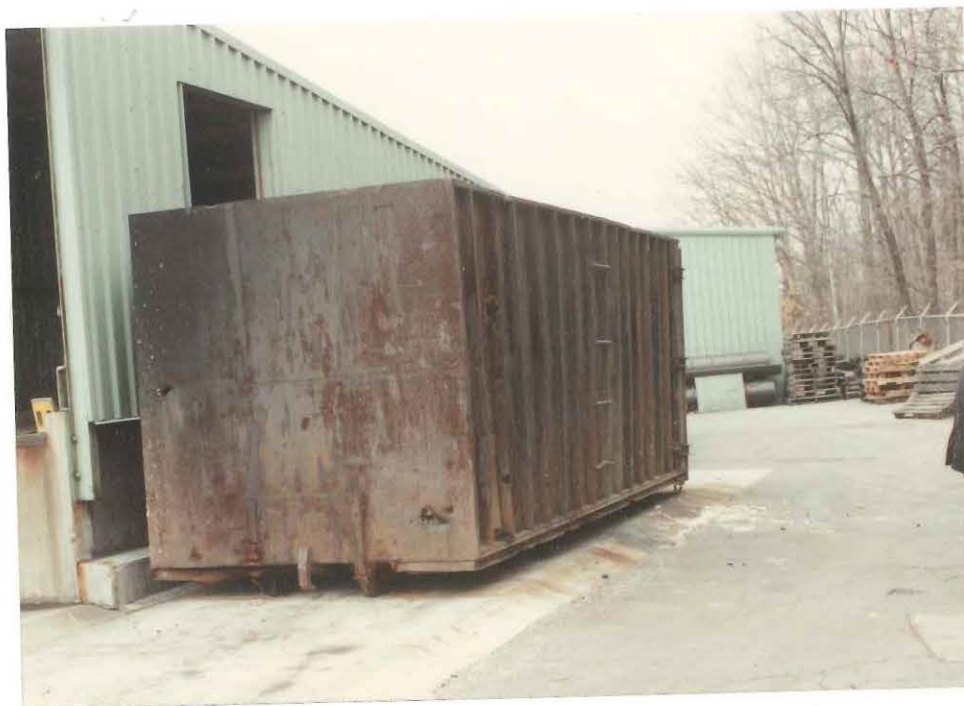
Unit Description: This outdoor unit is an approximately 50-cubic yard steel dumpster located north of the northeast corner of Building No. 6 (Pilot Plant). It is used for storage of waste non-heat-treated carbon solids, empty fiber drums, and old wooden pallets (Reference 31). According to facility representatives, approximately 850 cubic yards of this waste material is generated per year (Reference 32). The waste is picked up by a contractor and disposed of in a municipal sanitary landfill (Reference 32). This unit is uncovered and located above a concrete pad. During the VSI, rust stains and a white solid material were observed on the concrete pad adjacent to the unit; however, no evidence of release to soil was identified (Reference 31).

10. Carbon Waste Dumpster. View looking west of the approximately 50-cubic-yard steel unit. Scrap carbon generated in the Pilot Plant is placed in this unit, prior to transport to a municipal sanitary landfill.

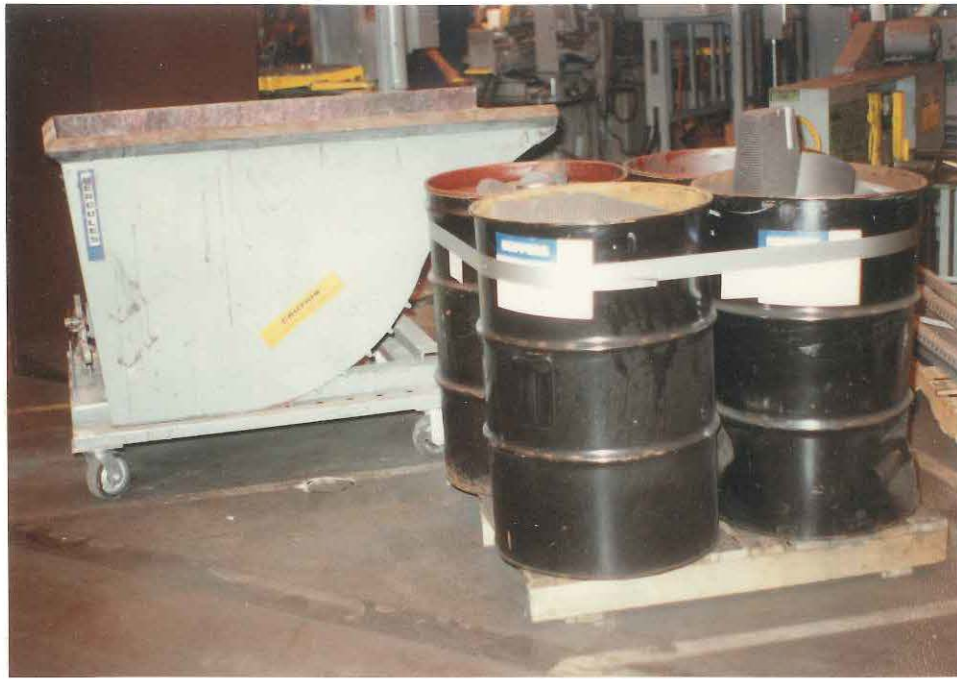
11. Satellite Scrap Graphite Accumulation Areas (SWMU 11) and
 & Satellite Scrap Carbon Dumpster (SWMU 12). Close-up view
 12. of a representative example of SWMU 11 (in the foreground)
 and SWMU 12 (in the rear of the photograph). Note the good
 condition of the concrete floor beneath these units.

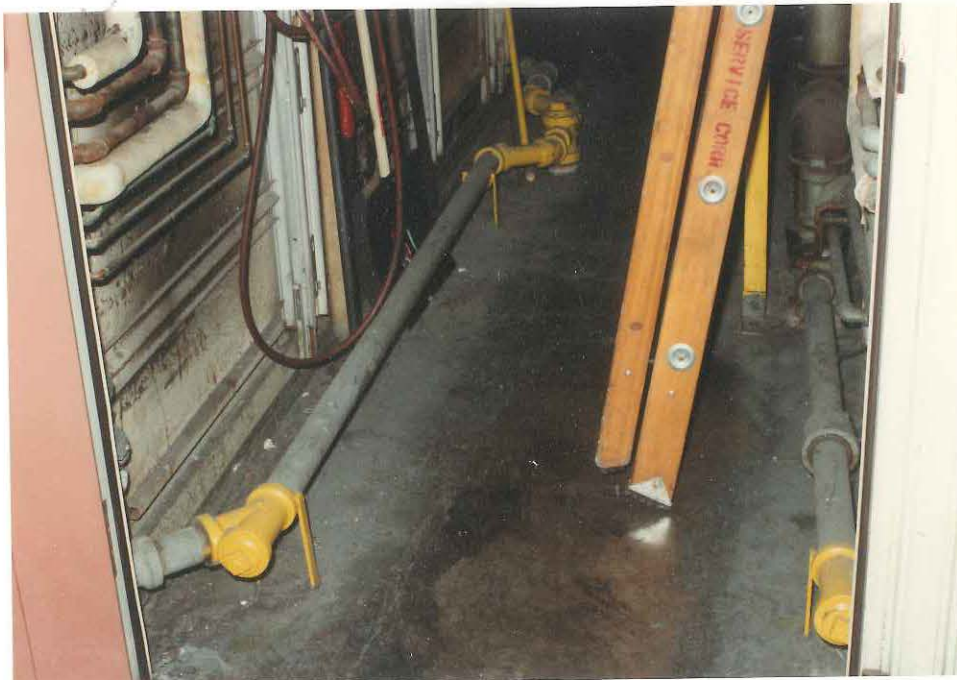
Unit Description: This indoor unit consists of the system of cast iron piping used to transfer dilute laboratory chemicals from sinks to the municipal sewer line. The piping is located in Building No. 1 in the service corridors between laboratories and leads to the municipal sewer line at locations within Building No. 1 (References 31 and 32). During the VSI, above-ground portions of this unit were observed to be in good condition (Reference 31).

13. Laboratory Chemical Disposal Piping. View looking east
 through a service corridor between laboratories in Building
 No. 1. Note the location of piping above the concrete
 floor at this location.

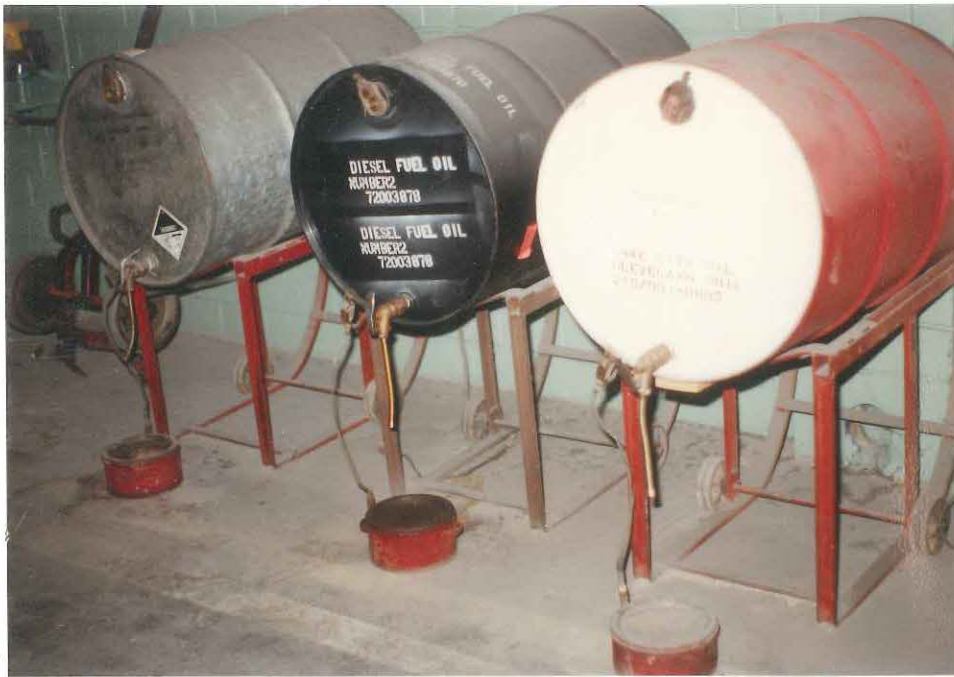
14. Raw Material Dispensing Room Leak Collection Cans.
Close-up view of these approximately one-half gallon steel containers. Note the location on a concrete floor beneath spigots of raw material drums.

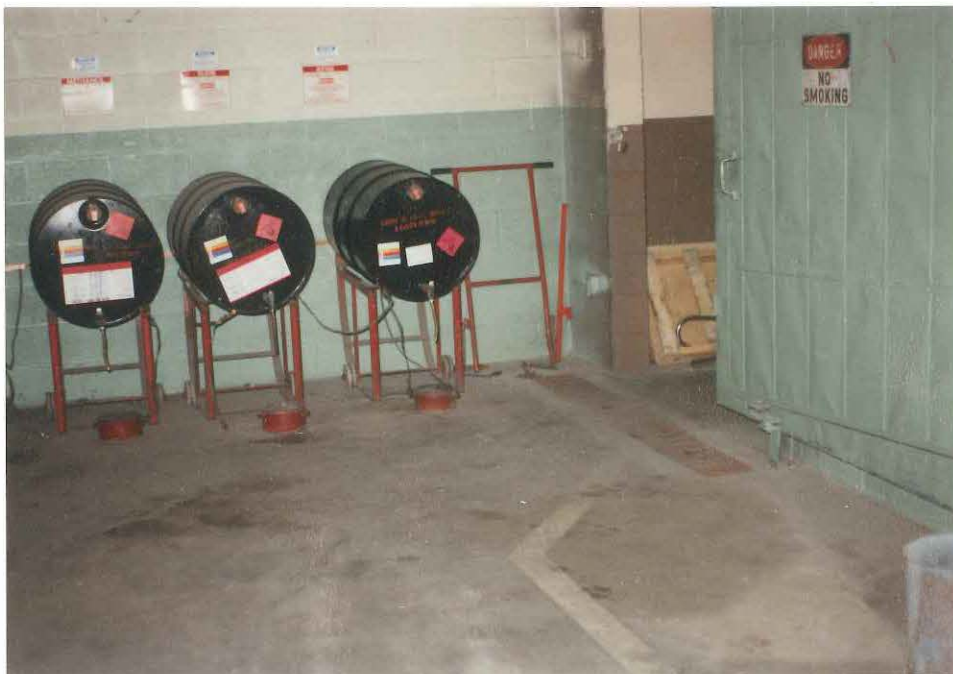
Unit Description: This indoor unit consists of two approximately four-foot-long by six-inch-wide by four-inch-deep in-ground concrete floor drains and associated piping located at two doorways of Room 10B (Raw Material Dispensing Room) at the north end of the Services Area of Building No. 1. The steel grate-covered drains are designed to collect and contain spills in the room. During the VSI, evidence of a solidified spilled material was observed in one of the drains and minor stains were observed on the concrete floor (Reference 31).

- 15.1 Raw Material Dispensing Room Floor Drains. View looking west of the in-ground steel grate-covered floor drains at the entrance door to Room 10B.

The potential for releases from SWMU #19 (Raw Material Dispensing Room Floor Drains) could not be determined, as the unit is below ground, and no file information exists on the destination or integrity of the drains. Therefore, it is recommended that this information should be determined, and that any observed problems should be corrected.

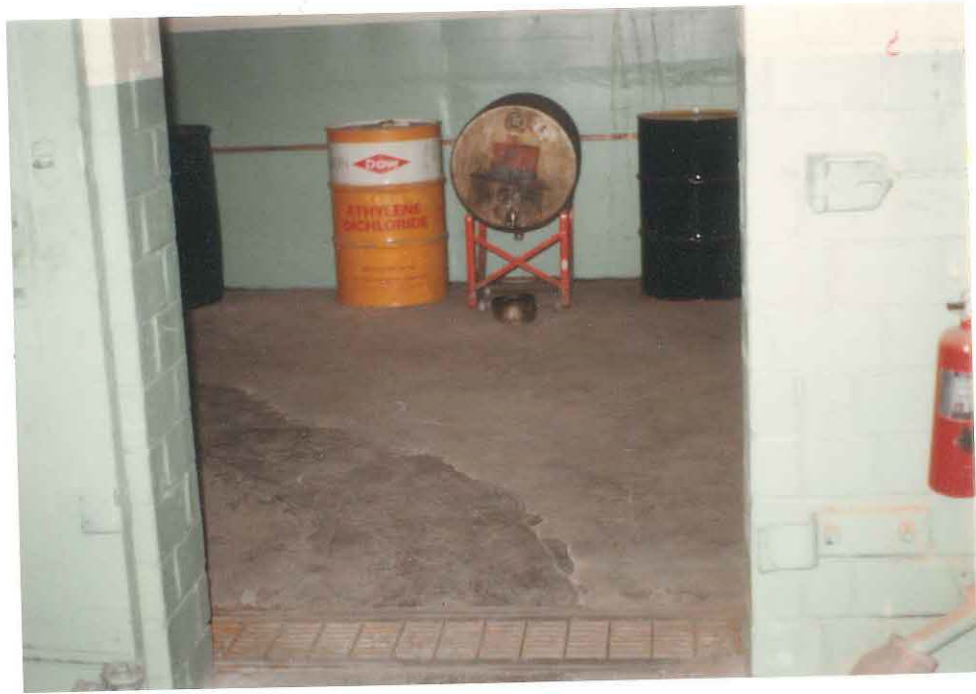
15.2 Raw Material Dispensing Room Floor Drains. View looking east of the in-ground steel grate-covered floor drain in the foreground at the entrance to the rear section of Room 10B.
